CRACKING MECHANISMS IN HY-130  
STEEL WELDMENTS.

OCEAN ENGINEER

Massachusetts Institute of Technology

June 1973

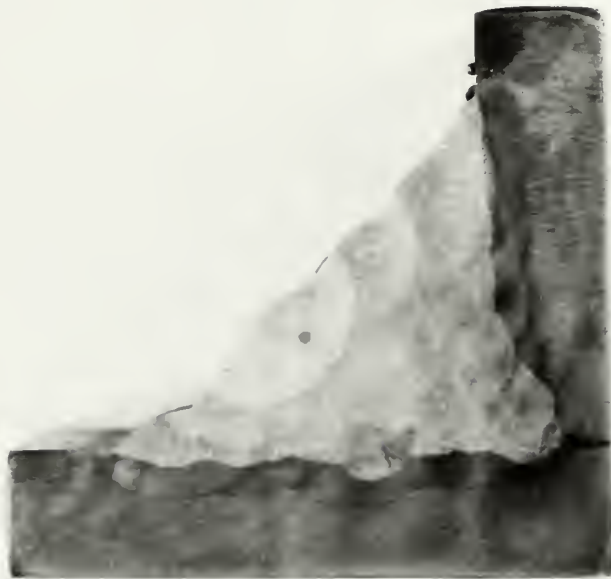
Figure 7

A view of the Heat Affected Zone of the  
Circular Fillet Welded Specimen.

The circular fillet welded specimen was sectioned to reveal the weld HAZ (Figure 7) and examined until a micro-crack was located. The examination was to determine the mode of cracking exhibited by the highly-restrained, full-scale weldment.

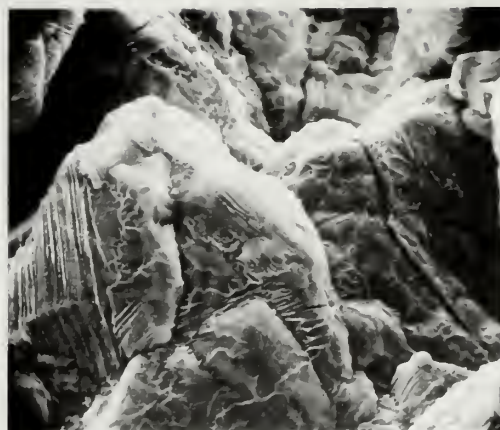
Figure 9. Microphotograph from the Scanning Electron Microscope (SEM) of specimen 216 showing intergranular cracking.

- Below 70% reduction of area, fracture was intergranular (Figures 9a,b,c and 10a,b). [The slight irregularity on the grain boundary is due to platelets of FeO on the surface of the grain].

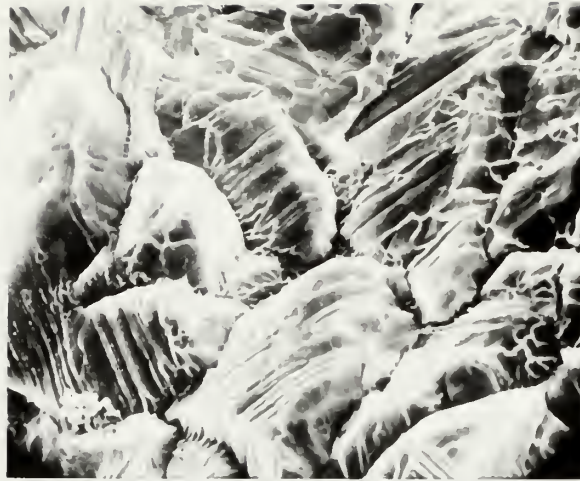
Figure 11. Microphotograph from the SEM viewing a mixed fracture of intergranular and transgranular cracking. (2250X)

- From 70% to about 83% reduction of area, there is a transition zone where the cracking mechanism is a combination of intergranular and transgranular fracture (Figure 11). Also in this zone there is the appearance of

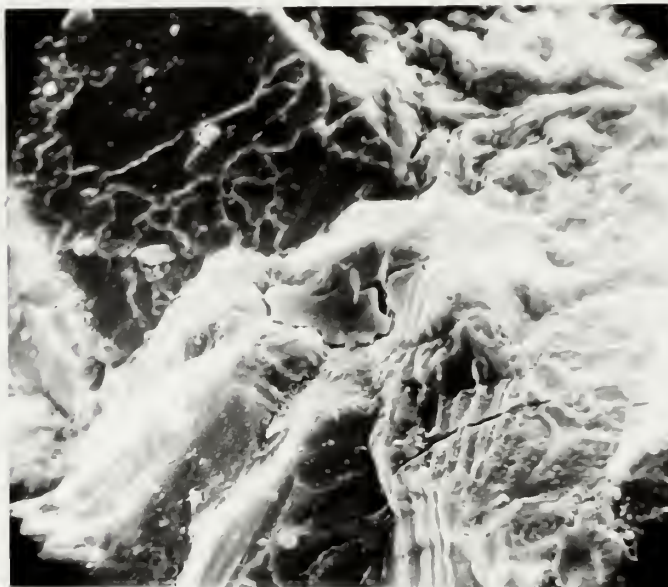
Figure 12. Microphotograph from the SEM observing the MnS inclusion found at the grain boundaries. (2375X)

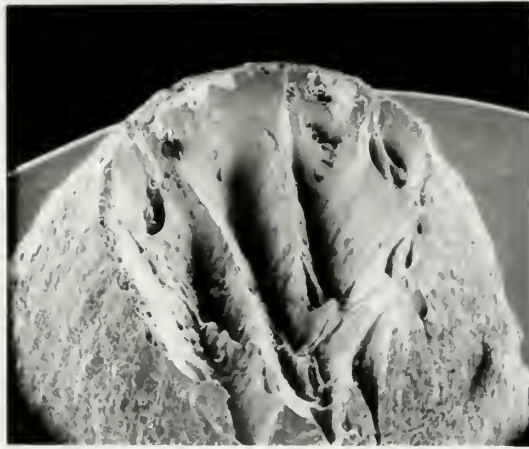
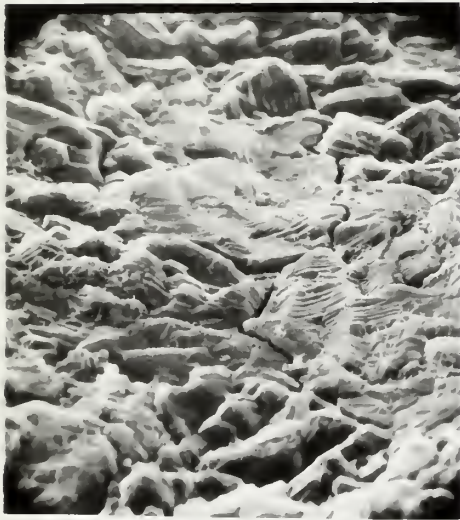
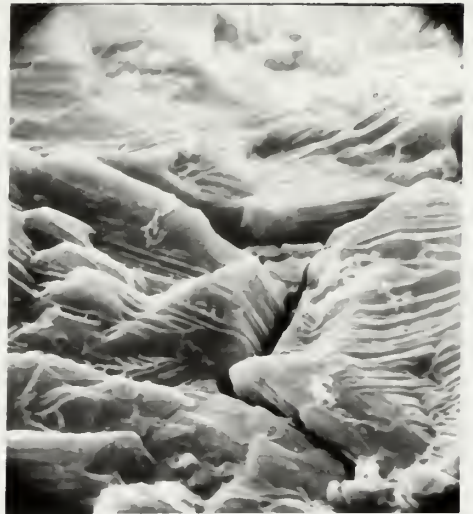
Figure 13. Microphotograph from the SEM  
viewing transgranular cracking of specimen 1L7.

• Above 85% reduction of area the fracture mechanism was transgranular. (Figures 13a,b,c).

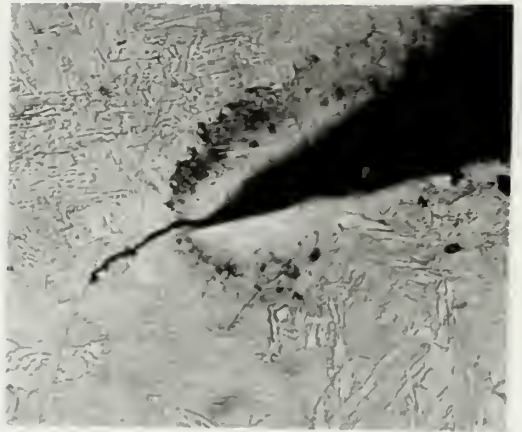
Figure 14. Transgranular Crack  
in NCFW Specimen. (500X)

B. Welded Specimen examination - The examination of the circular fillet welded specimen revealed several macrocracks at the fusion line in addition to the microcracks which developed in the HAZ adjacent to the fusion line. In every instance investigated there was a MnS inclusion at the center of the macrocracks. The crack culminated with a transgranular "tail" extending outward from the center (Figures 14,15).
